Document Number : IB-24-18

Title : Change in the Display Front and the LCD Bracket of InBody270

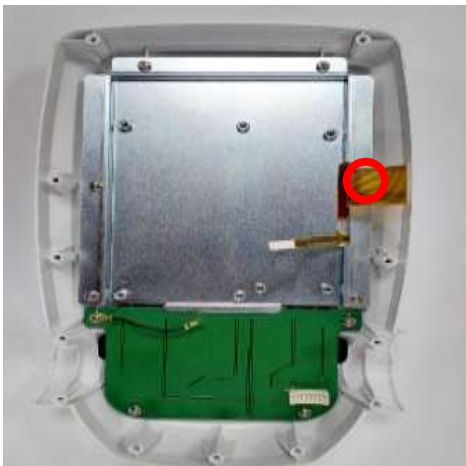
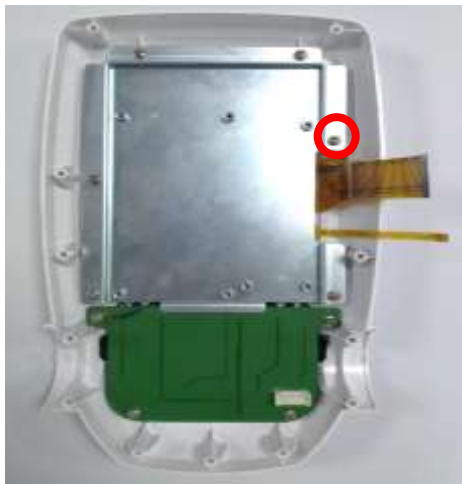
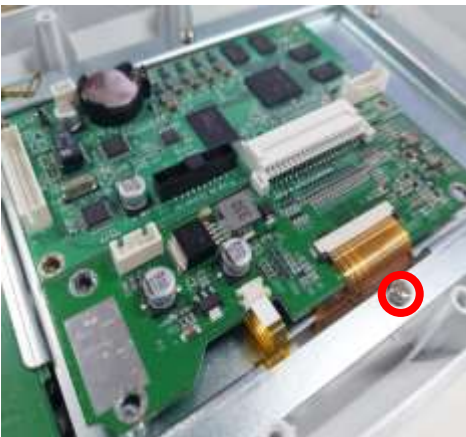
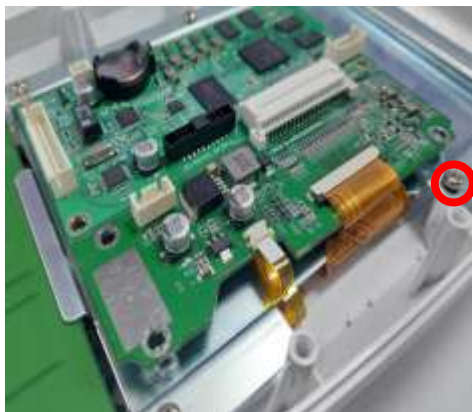
3. Changed Details

The screw position has been changed to address the issue where the interference of the LCD Bracket and the Display Front damages the LCD FFC Cable during the manufacturing process.

Since the changed parts are not compatible with the old spare parts, both the LCD Bracket and the Display Front must be replaced as a pair.
